# TEST REPORT

No. : GZIN1607030154MR

Sample Name : CORN ELECTRICAL ENCLOSURE  
SGS Ref. No. : GZRL2016071640  
Style / Item No. : PEGASUS SHIELD SYSTEM  
Manufacturer : CORN ENCLOSURE SOLUTIONS LIMITED  
Date of Receipt : Jul 04, 2016  
Testing Start Date : Jul 04, 2016  
Testing End Date : Jul 27, 2016  
Test result(s) : For further details, please refer to the following page(s)

## Summary of Results:

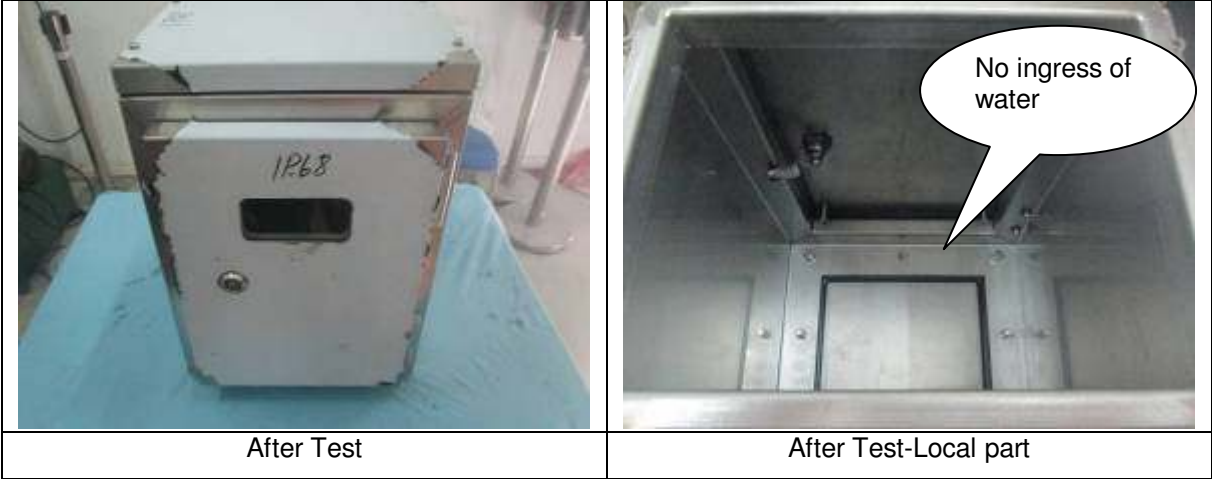
Test Photo:

1. Test Item: IPX6

Nozzle diameter:  $\Phi$  12.5 mm

Flow rate: 100 L/min  $\pm$  5 %

Distance: 2.5 m ~3.0 m

Test duration: 3 min

Sample	Test Result
1	No ingress of water

Equipment	Model	Equipment No.	Calibration date	Next Calibration date
Waterproof tester	IPX3-7	GZMR-RL-E106	2015-07-13	2016-07-12

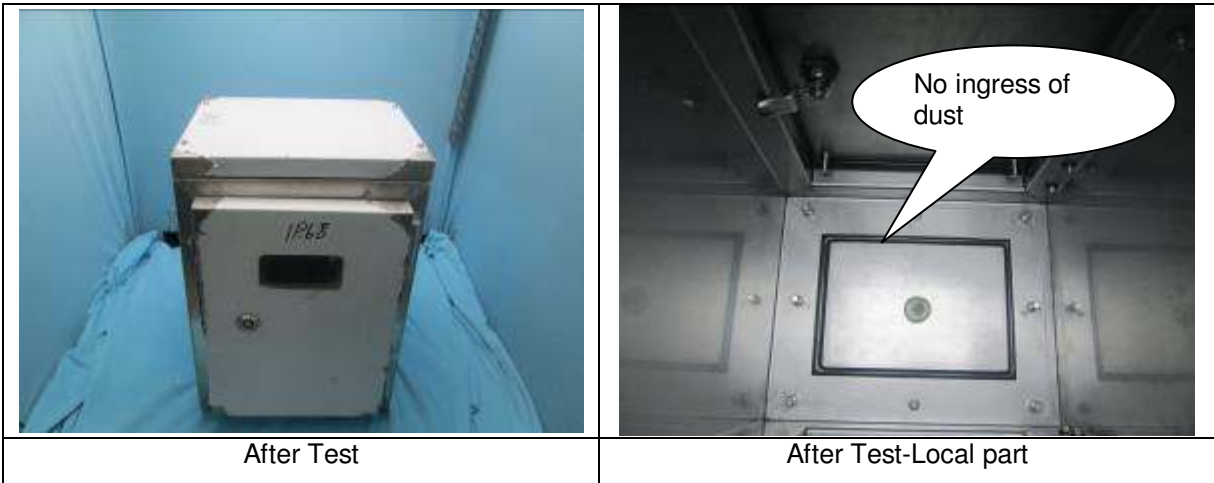
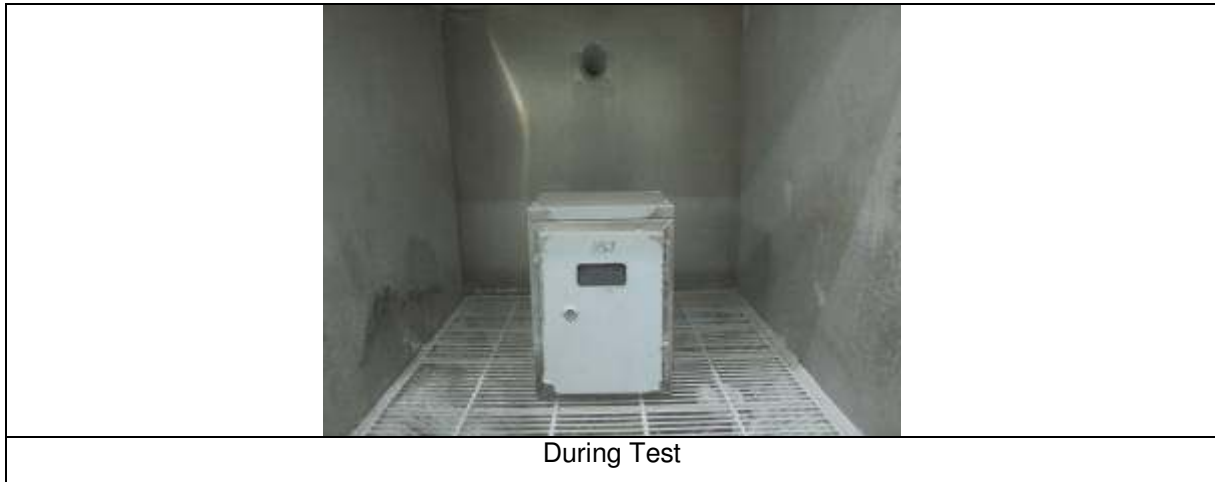
Test Photo:

2.Test Item: IP6X

Test Dust: Talcum powder

Dust Concentration: 2 kg/m<sup>3</sup> chamber volume and be kept in suspension during the test

Depression: ≤2 kPa

Test Duration: 8 hours

Sample	Test Result
1	No ingress of dust

Equipment	Model	Equipment No.	Calibration date	Next Calibration date
Sand and dust test chamber	SC-010	GZMR-RL-E070	2016-03-16	2017-03-15
